DEPARTMENT OF TRANSPORTATION

Contract #: 04-0120F4Cty: SF/ALA Rte: 80 PM: 13.2/13.9File #: 1.28**WELDING INSPECTION REPORT****Resident Engineer:** Casey, William**Address:** 333 Burma Road**City:** Oakland, CA 94607**Report No:** WIR-027008**Date Inspected:** 09-Jan-2012**Project Name:** SAS Superstructure**OSM Arrival Time:** 700**Prime Contractor:** American Bridge/Fluor Enterprises, a JV**OSM Departure Time:** 1530**Contractor:** American Bridge/Fluor Enterprises, a JV**Location:** Job Site**CWI Name:** See below**CWI Present:** Yes No**Inspected CWI report:** Yes No N/A**Rod Oven in Use:** Yes No N/A**Electrode to specification:** Yes No N/A**Weld Procedures Followed:** Yes No N/A**Qualified Welders:** Yes No N/A**Verified Joint Fit-up:** Yes No N/A**Approved Drawings:** Yes No N/A**Approved WPS:** Yes No N/A**Delayed / Cancelled:** Yes No N/A**Bridge No:** 34-0006**Component:** SAS**Summary of Items Observed:**

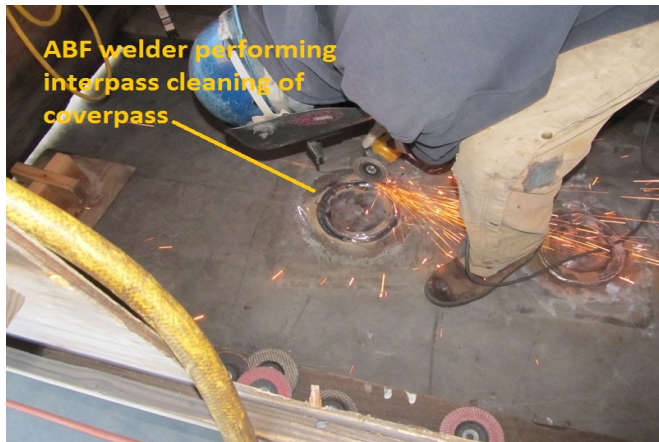
11W-pp103-W4-1

Upon the arrival of the QA Inspector at the above identified location, the ABF welder Mike Jimenez was observed

excavating and repairing the above identified weld joint. The QA Inspector randomly observed the ABF welder excavate the previously rejected areas utilizing a burr bit grinder and a grinding disc. The QA Inspector noted the rejected areas were previously indicated with a distinguishing marking indicating the location of the weld defects. The QA Inspector noted a total of (3) three rejected areas in the above identified weld joint. Once the areas were excavated and ground to a weldable profile, the QC Inspector Salvador Moreno performed magnetic particle testing of the excavations. The QC Inspector informed the QA Inspector no relevant indications were located at the time of the testing. The QA Inspector noted the dimensions of the excavations were as follows: 1.) D=7mm, W=15, L=65mm, 2.) D=9mm, W=12, L=63mm and 3.) D=12mm, W=12mm, L=63mm. The QA Inspector randomly observed the ABF welder preheat the excavated areas and the surrounding base material to 100 degrees F prior to performing the SMAW repair. The QA Inspector randomly observed the ABF welder begin the SMAW repairs utilizing 1/8" E7018 low hydrogen electrodes and 120 Amps. The QA Inspector randomly observed and noted the weld repairs were completed on the QA Inspectors shift. After the repairs were completed the QA Inspector observed the ABF welder grind the weld reinforcement flush with the base metal.

As a courtesy the QA Inspector asked the QC Inspector John Pagliero to perform UT of an area that was previously accepted by him. Mr. Pagliero performed the additional UT at the request of the QA Inspector. Mr. Pagliero informed the QA Inspector he was able to reproduce the same rejectable indication located by the QA Inspector. The QC Inspector informed the QA inspector he would reject the weld and have the area excavated and repaired.
